# **Deer Harbor Estuary Habitat Restoration Project Orcas Island, Washington**

## **Appendices to Environmental Assessment and Feasibility Study Report**

**Prepared by:  
Deer Harbor Restoration Project Team  
Pursuant to IAC/ SRFB Grant No. 02-1577N  
October 2005**

### Predicted Physical Changes to Cayou Estuary Following Replacement of the Bridge

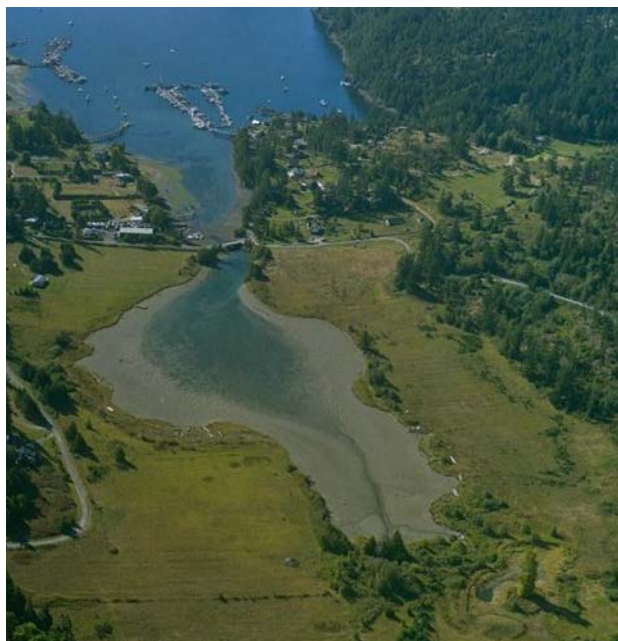
**Figure 1.**

This photo is from the Ecology Shorelines website (below) and shows Cayou Estuary and its bridge looking southward into Deer Harbor during a moderately (about 5.0') high tide. A fresh water stream can be seen near the bottom of the photo. A narrow band of *Salicornia* grows around the estuary perimeter, with salt tolerant grasses beyond. Rock fill under the bridge has partially restricted water exchange, and has enhanced sediment deposition within the estuary by creating pond-like conditions.

Cayou Estuary (Figure 1) is a tidal flat (as defined by Downing, 1983. "The Coast of Puget Sound") located at the head of Deer Harbor. It is partially enclosed, with a narrow opening to Deer Harbor and a small stream at its head. The sediment in the estuary is several feet thick, fine grained and muddy. Due to its small size and protected nature, there is low wave energy and little input of sediment from Deer Harbor. The intermittent stream and biological production are probably larger sources of sediment to Cayou Estuary than are marine derived sources. Similar tidal flats (presented below) are found throughout the Cascadia region at the mouths of creeks and at the heads of quiet bays.

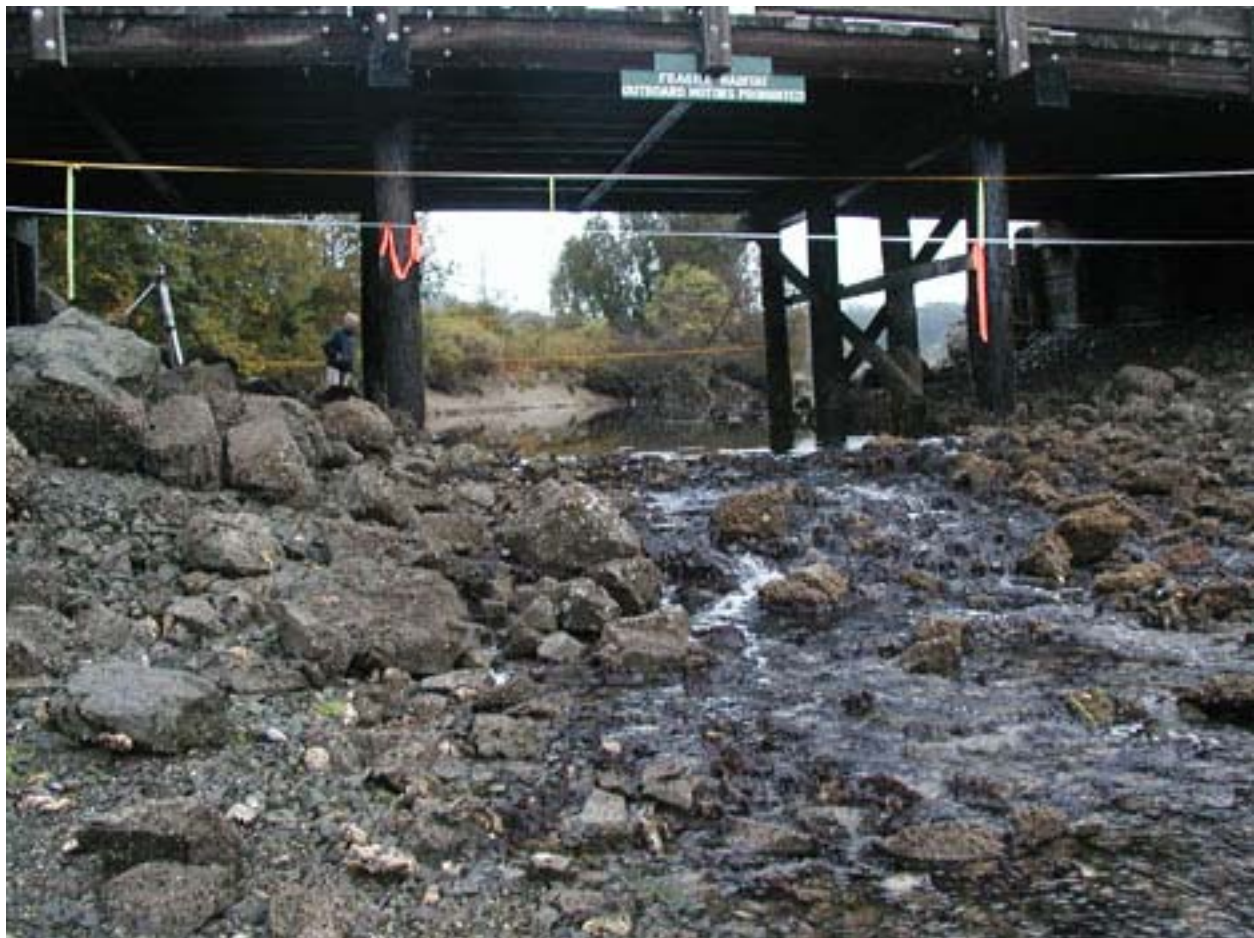
**Figure 2.** This photo is looking northward into Cayou Estuary to show the rock dam under the existing bridge. Notice the ponded water in the estuary.

The existing timber bridge (Figures 2 and 3) is constructed with its timber footers and earthen approaches within the intertidal zone. Its span is too short by today's standards, and a rock dam constructed beneath impedes tidal exchange. Survey measurements show that water

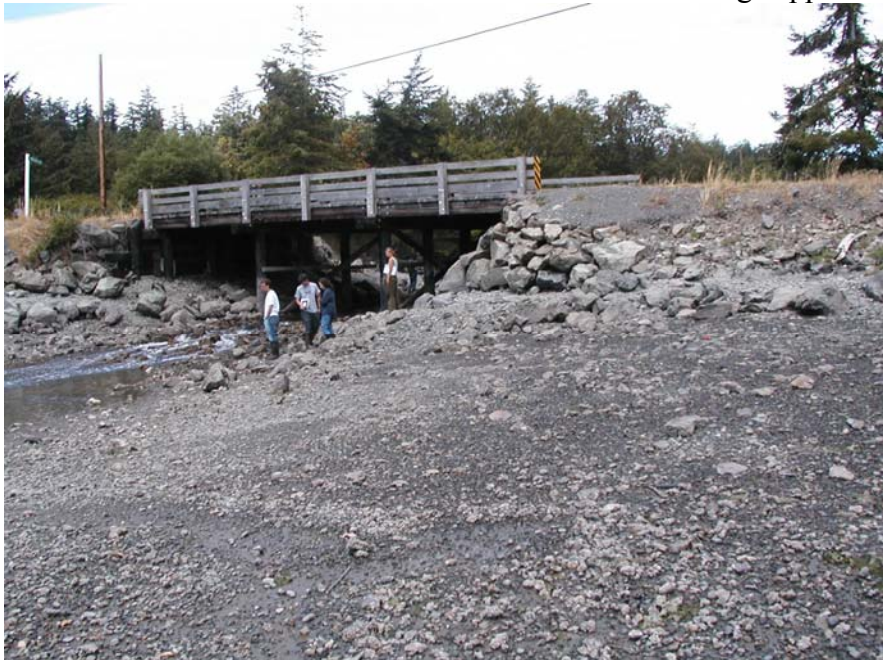
**Figure 4.**

A portion of the beach fill is visible in this picture. The bridge approaches extend out 80 feet onto the beach from one side and 20 feet on the other, filling a portion of the intertidal zone with angular quarry rock

Considerable beach fill is associated with the bridge approaches and footings (Figure 4).

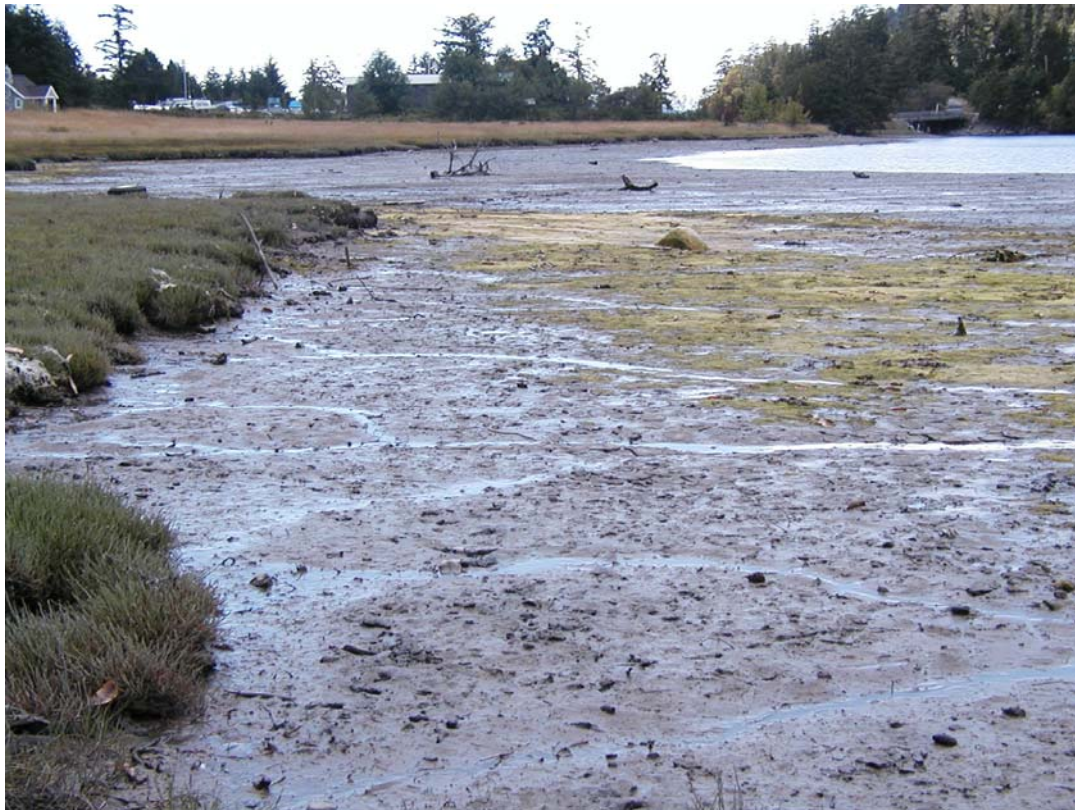
**Figure 8.** Seepage into Cayou Estuary is most obvious along the eastern shore, as seen here during July 2003. *Salicornia* is visible to the left to indicate elevation. Russell Barsh found that the water in this area had lower salinity than seawater, confirming that the seepage has measurable influence on Cayou Estuary hydrodynamics, and is comprised at least in part of freshwater, not just seawater seepage from the intertidal range. The green seaweed (possibly *Ulva*) may be associated with the fresh water.

Freshwater seepage enters the estuary, with flows obvious during low tide, even in summer (Figure 8).

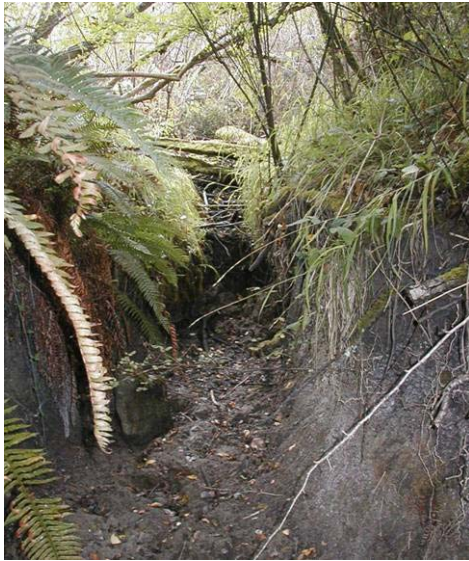
**Figure 9.**

Fishtrap creek is significantly downcut for a distance of about 120 yards, with an average depth of 2 yards and width of 7 yards. This picture shows the headwall at the upstream extent of the cut. Speculation is that the creek's baseflows are significantly less than historically occurred, but storm flow is intense enough to cause the downcutting seen here.

It is easy to see that significant erosion has occurred in Fishtrap Creek and in the Cayou Estuary. Two areas of recent scour were observed, including Fishtrap Creek downcutting (Figure 9) and along the west bank of the estuary just upstream of the bridge (visible near the center, behind the bridge in Figure 2). The creek and bank erosion combined with biological detritus are believed to be the major sources of sediment to the estuary.

As an approximation based on field measurement with a tape measure as described in Figure 9, the Fishtrap Creek erosion is estimated:

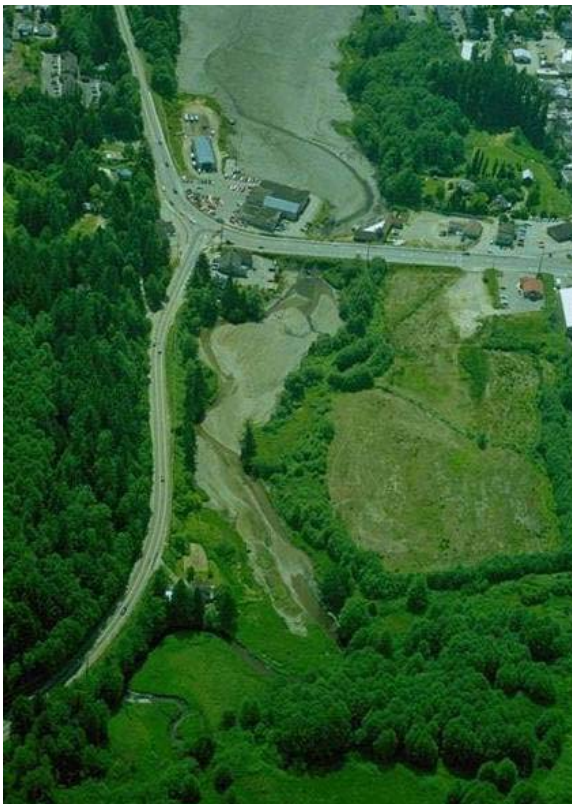
**Figure 10.**

This photo is from the Ecology Shorelines website and shows Dogfish Creek and its bridge looking southward into Liberty Bay, Poulsbo during a low tide. The bridge was recently replaced and downcutting and erosion of marine mud occurred.

The most similar case of removing a dam at the mouth of an estuary is Dogfish Creek at Liberty Bay in Poulsbo, Kitsap County (Figures 10, 11 and 12). An undersized culvert was replaced with a new bridge during 2003. As a result, a new stream channel has carved itself into the soft marine mud in the vicinity. The main difference between Cayou Estuary and Dogfish is that Dogfish Creek is a much larger creek than Fishtrap Creek, and so the size of any newly carved channel is expected to be less at Cayou Estuary.

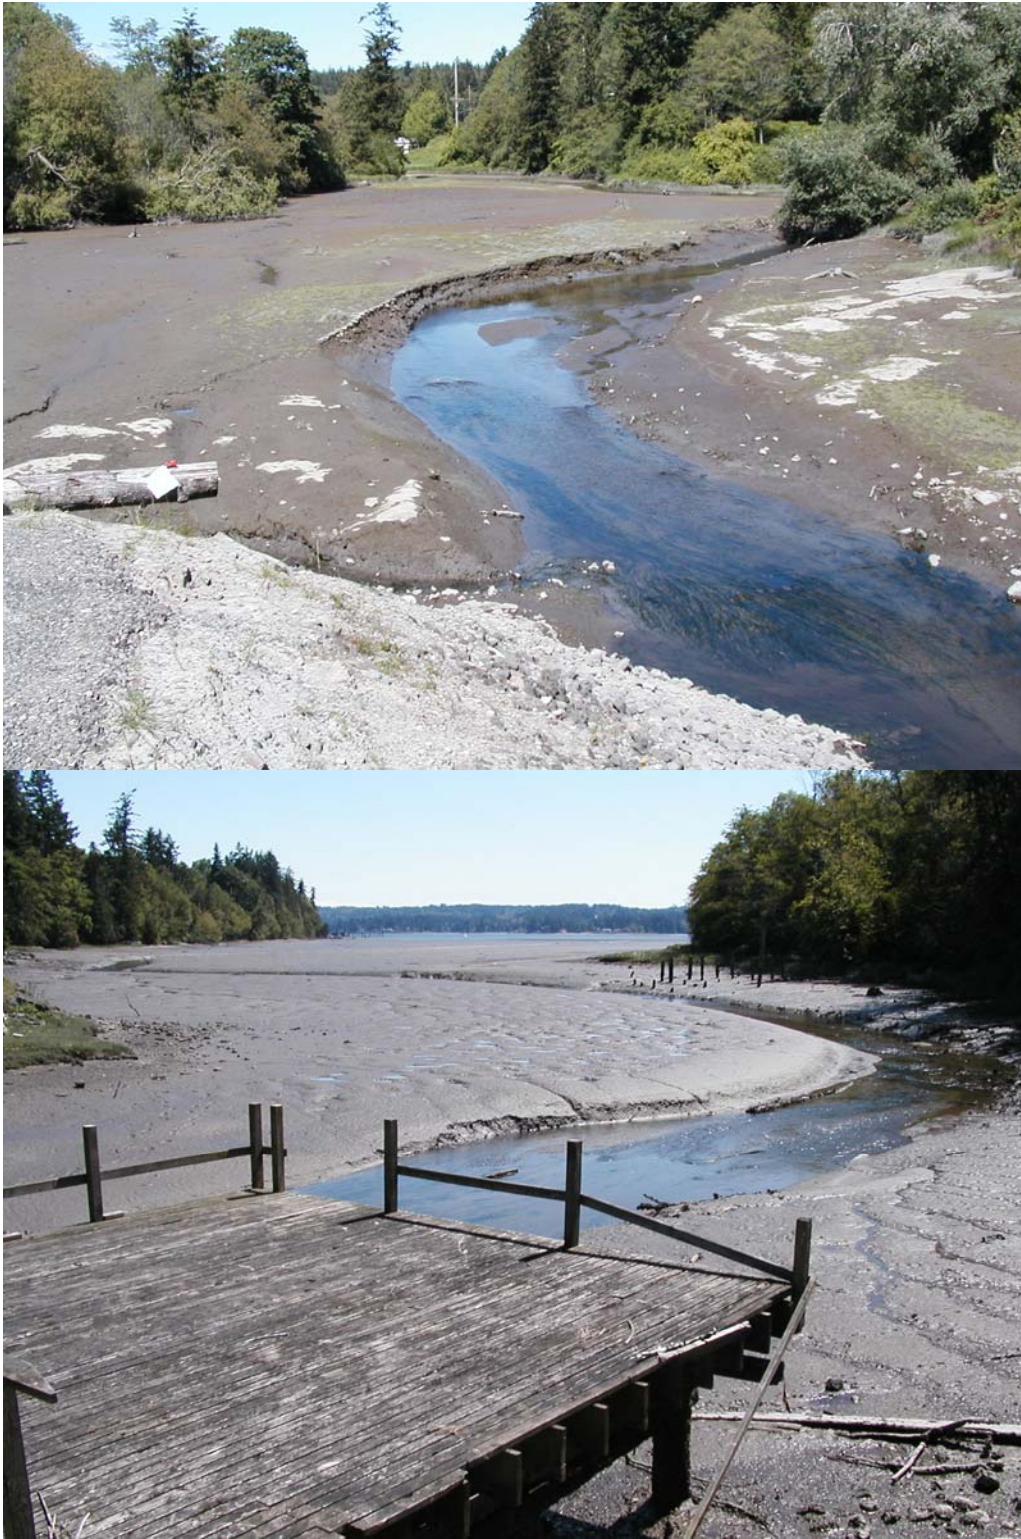
**Figures 11 and 12.** Liberty Bay at Dogfish Creek, Poulsbo, Kitsap County. Top: Looking upstream from new 2003 bridge during 2005. Bottom: Looking downstream. The new bridge replaced a slightly perched culvert, and a stream downcut about 2 feet in 6 months as can be seen in the top photo. Note *Salicornia* to left of lower photo for elevation.

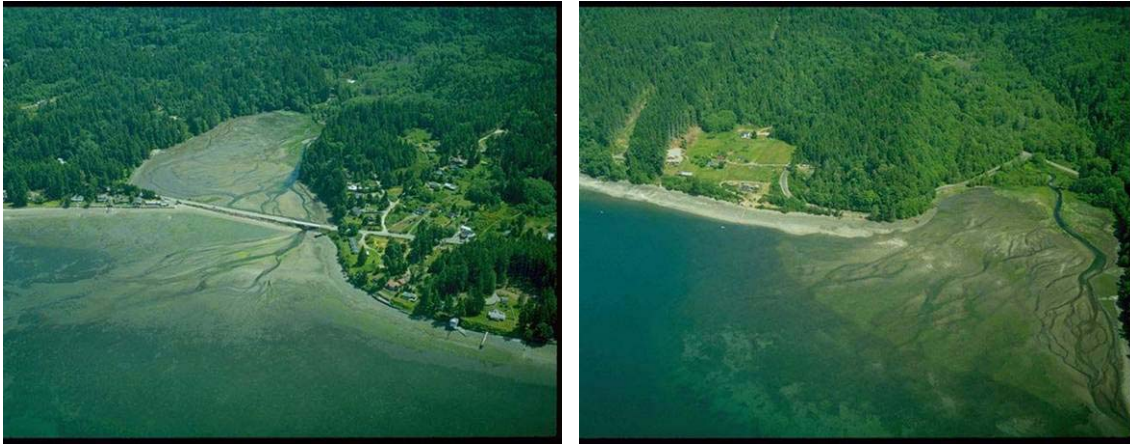
**Figure 13.** Big Beef Creek and Miller Bay. Ecology photos.

Other similar areas are shown in Figures 13 through 17. These pictures show the general shape of drainage channels across tidal flats. Note that the typical situation is with meandering channels within the intertidal range. It is my belief that removal of the rock dam at Cayou Estuary bridge would allow the development of a meandering channel within Cayou Estuary.

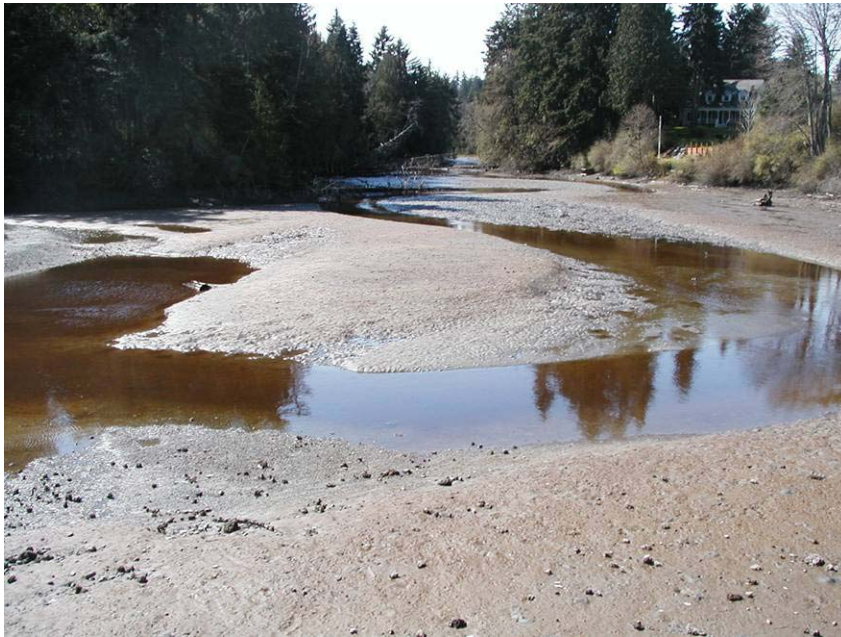
**Figure 16.** Appletree Cove and Carpenter Creek. I believe that this picture is representative of future conditions in the southern half of Cayou Estuary following bridge removal. This channel is 40 feet across with a maximum depth of 3.5 feet and an average depth of 2.1 feet.

Another location that is quite similar to Cayou Estuary is Appletree Cove in Kingston (Figures 16 and 17). The Appletree Cove watershed is 486 acres, a bit smaller than that of Cayou Estuary, but it receives more rainfall. I suspect that the overall flows are very similar to Cayou Estuary, but the main difference is that the outlet goes through a culvert that does not appear to block the outflow nearly as much as does the bridge at Cayou Estuary. Thus, Appletree Cove and its small tributary creek, Carpenter Creek, might be reasonable case studies for the expected future condition in Cayou if the dam was removed.

- I anticipate that the size of the channels will be as found in Appletree Cove as presented in Figures 16 and 17. I postulate that the speed of washout shall be on the order of two years as found in Dogfish Creek at Liberty Bay. Thus, Appletree Cove is used as a reference reach for channel morphometry, and Dogfish Creek is used as the reference area with respect to timing.

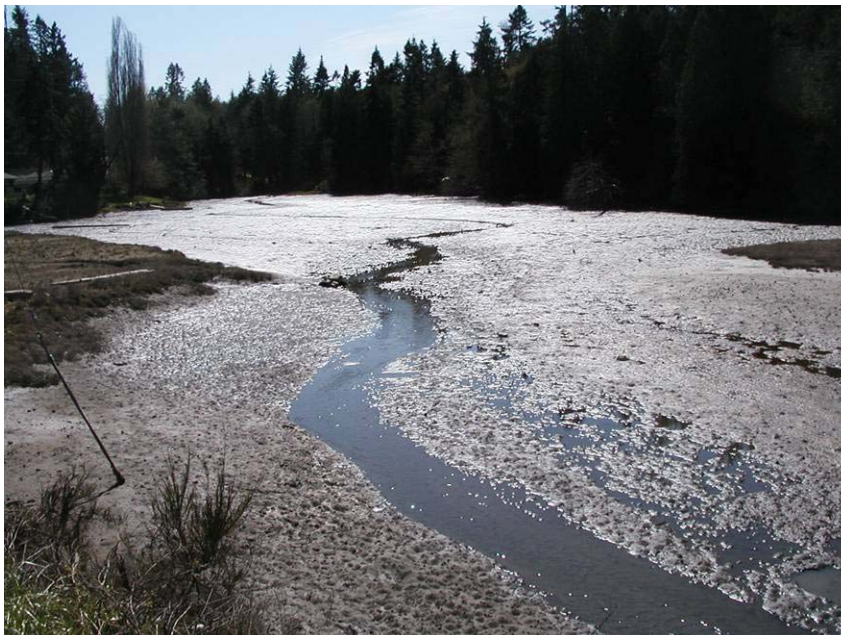
**Figure 17.** Appletree Cove and Carpenter Creek. I believe that this picture is representative of future conditions in the northern half of Cayou Estuary, where combined freshwater and tidal flow volumes are small, following bridge removal. Note *Salicornia* to left of lower photo for elevation. This channel is 14 feet across with a maximum depth of 1.2 feet and an average depth of 0.5 feet.

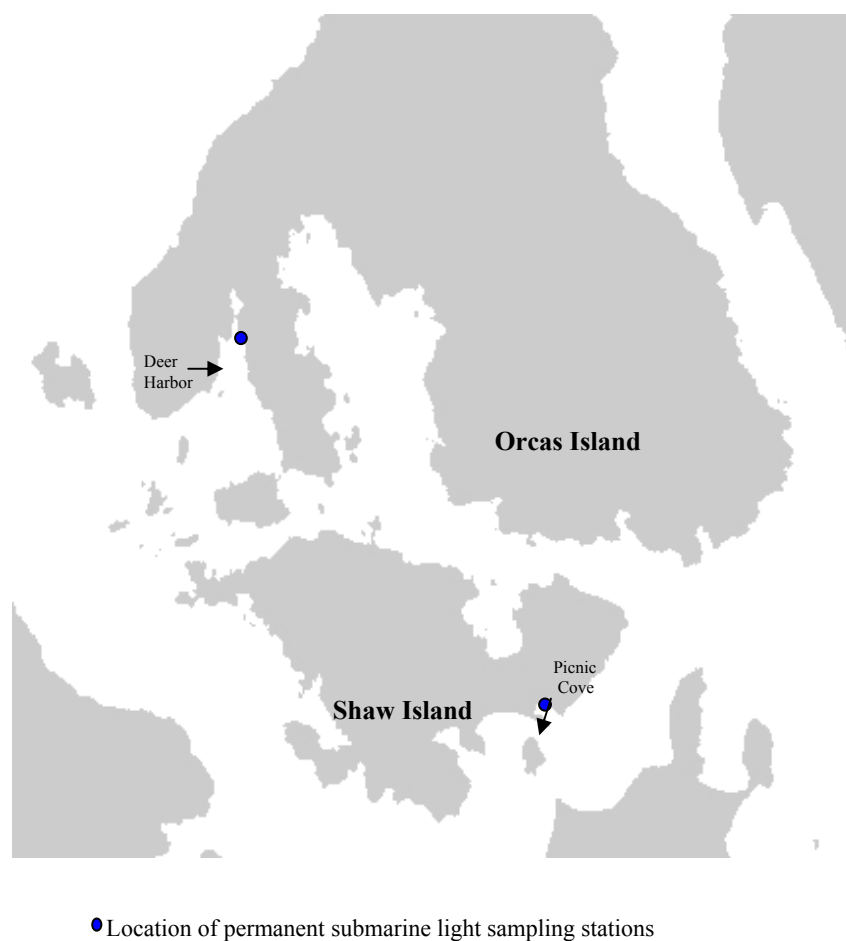
Figure XX. Permanent submarine light sampling stations located within Deer Harbor and Picnic Cove.

We established two permanent stations within the study area and one in a control site within Picnic Cove on the southern side of Shaw Island (Figure XX and Figure YY). Picnic Cove is a permanent reference station for the Washington State Department of Natural Resources, Submerged Vegetation Monitoring Program (Berry et al. 2003). Yearly estimates of *Z. marina* bottom cover are calculated and indicate that the population at this site has remained relatively stable since 2000. At each permanent station vertical transects were sampled within 2 hrs of solar noon using a spherical 4 $\pi$  sensor (Zimmerman et al. 1991; Carruthers et al. 2001). Sampling began on 2 July 2003 and continued until 19 April 2004 and sampling events occurred in each season (Table WW). Attenuation coefficients (the relationship between available PAR (wavelengths 400-700 nm) and depth) were calculated for each date at the each station in Microsoft Excel (Zimmerman et al. 1991; Carruthers et al. 2001). Statistical comparisons were made using the student *t*-test ( $\alpha = 0.05$ ) in Microsoft Excel.
