Deer Harbor Estuary Habitat Restoration Project Orcas Island, Washington

Environmental Assessment and Feasibility Study Report

**Prepared by:
Deer Harbor Restoration Project Team
Pursuant to IAC/ SRFB Grant No. 02-1577N
October 2005**

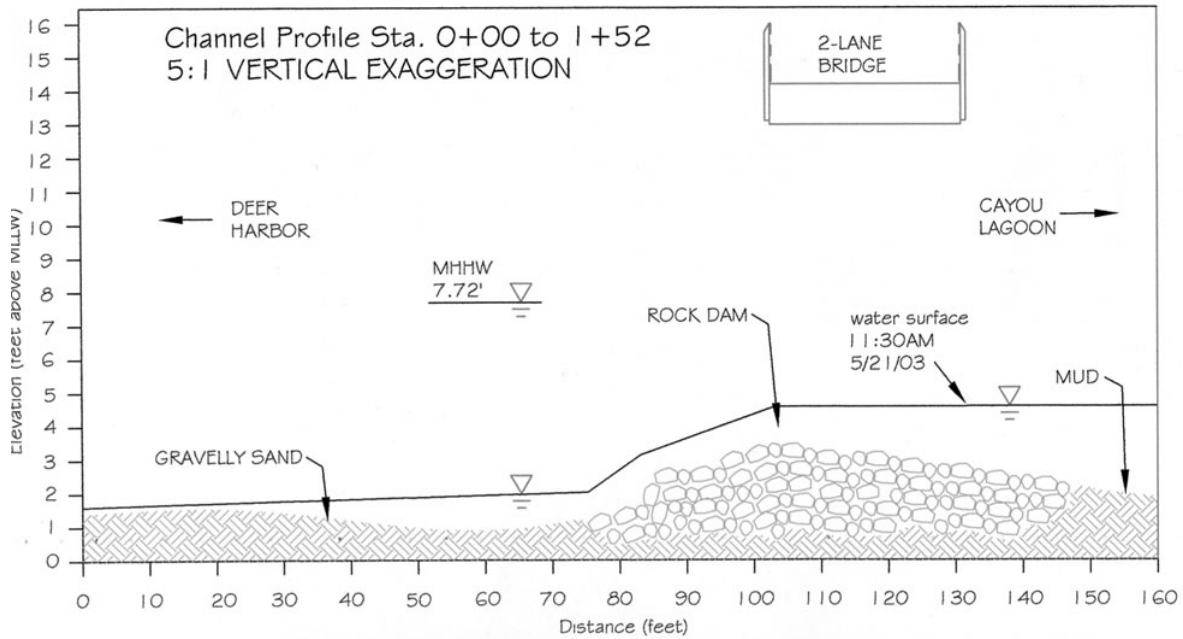
Figure 2.2 Channel Road Bridge Plan and Profile Views

(The profile view elevation datum is approximate and does not correspond with the plan view's precise datum.)

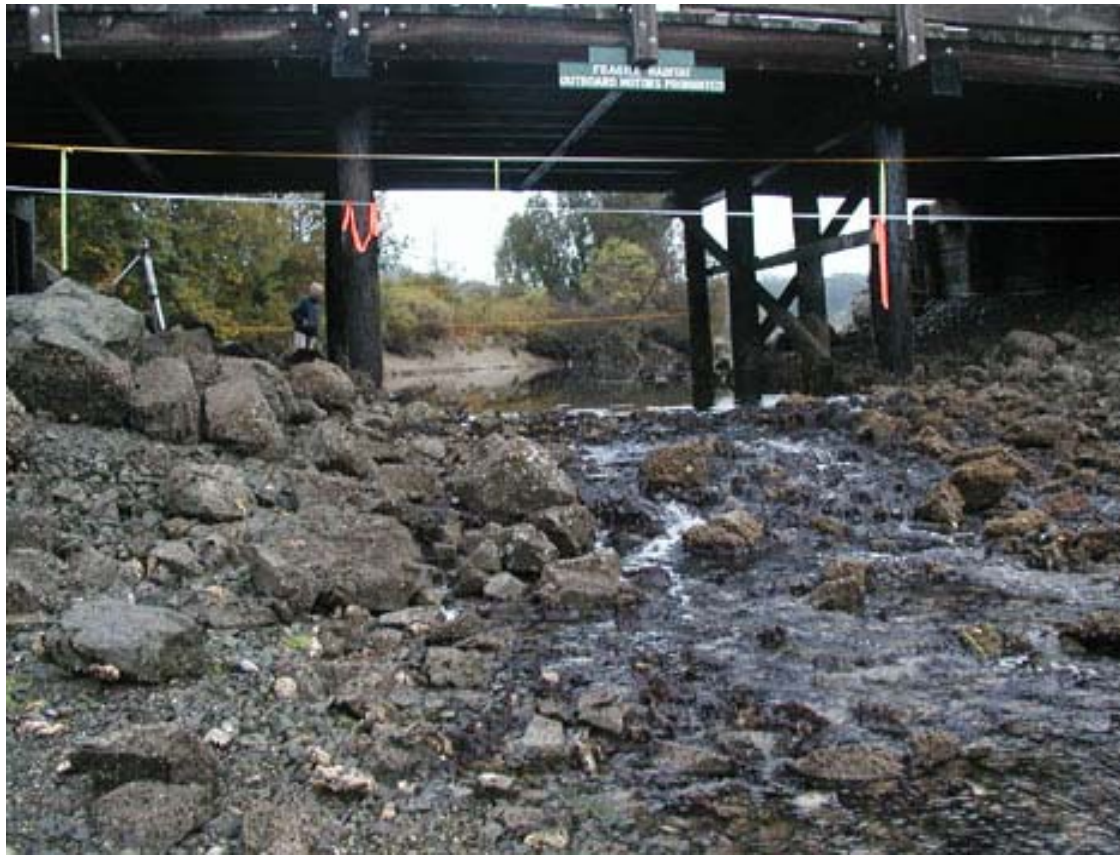
Figure 2.3 Channel Road Bridge and Cayou Valley Lagoon Outlet Channel

The existing Channel Road Bridge is supported by two sets of timber piling. The outlet channel at low tide clearly shows the rip rap “sill” that forms a permanent pool in the lagoon upstream of the bridge. An area of the lagoon bank that is actively eroding is seen in the background.

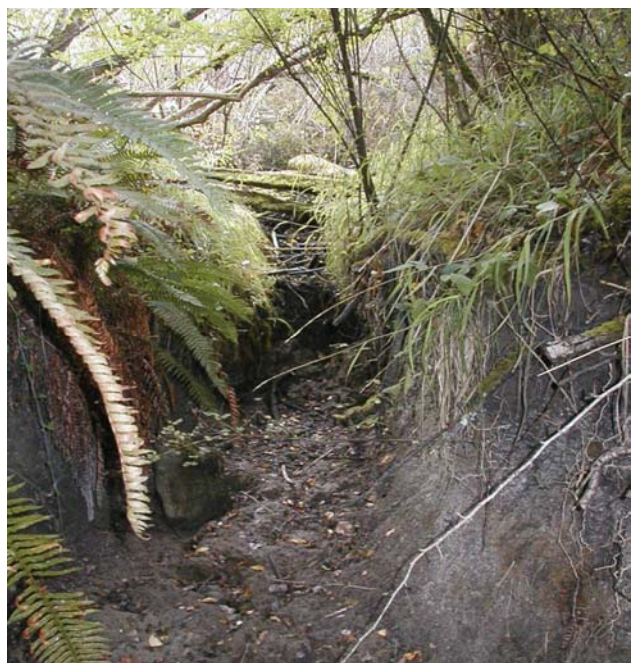
Figure 2.8 Fish Trap Creek Head Cut

The lowest, tidally-affected reaches of the two tributary creeks have been significantly altered by development activities in the watershed. Fish Trap Creek, which is the larger of the two creeks, flows into the estuary through a steep, narrow ravine eroded out of the native clay soil. The ravine extends about 200 feet upstream to a 5 foot-high vertical head cut, which marks the end of the zone of tidal influence. Although the history of the head cut is not documented, it is conjectured that it originated with dredging of the mouth of the creek in the late 19th Century for a dock, and then unraveled upstream during extreme runoff conditions in the first decades after the surrounding forest was logged and cleared for agriculture. Figure 2.8 shows the head cut.

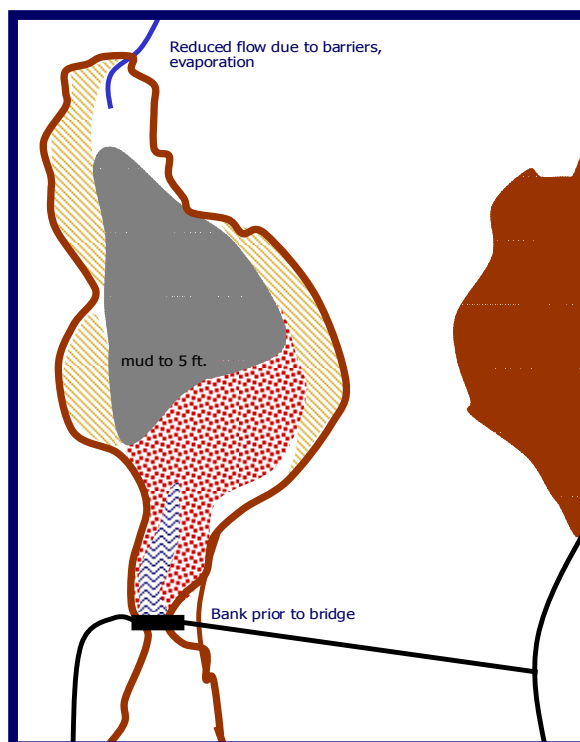
Cayou Lagoon was carved from finely bedded glacial clays that can still be seen 3 feet below the present surface. Over millennia, scouring resulted in the accumulation of gravel/pebbles excavated from the clays, creating a relatively firm bottom. There is also evidence of periods of re-suspension and re-accumulation of clays.

Channel constriction has increased scouring in the lower lagoon, while diminished streamflow has increased mud accumulations in the upper lagoon. In response to sediment accumulation the lagoon has been cutting a wider basin.

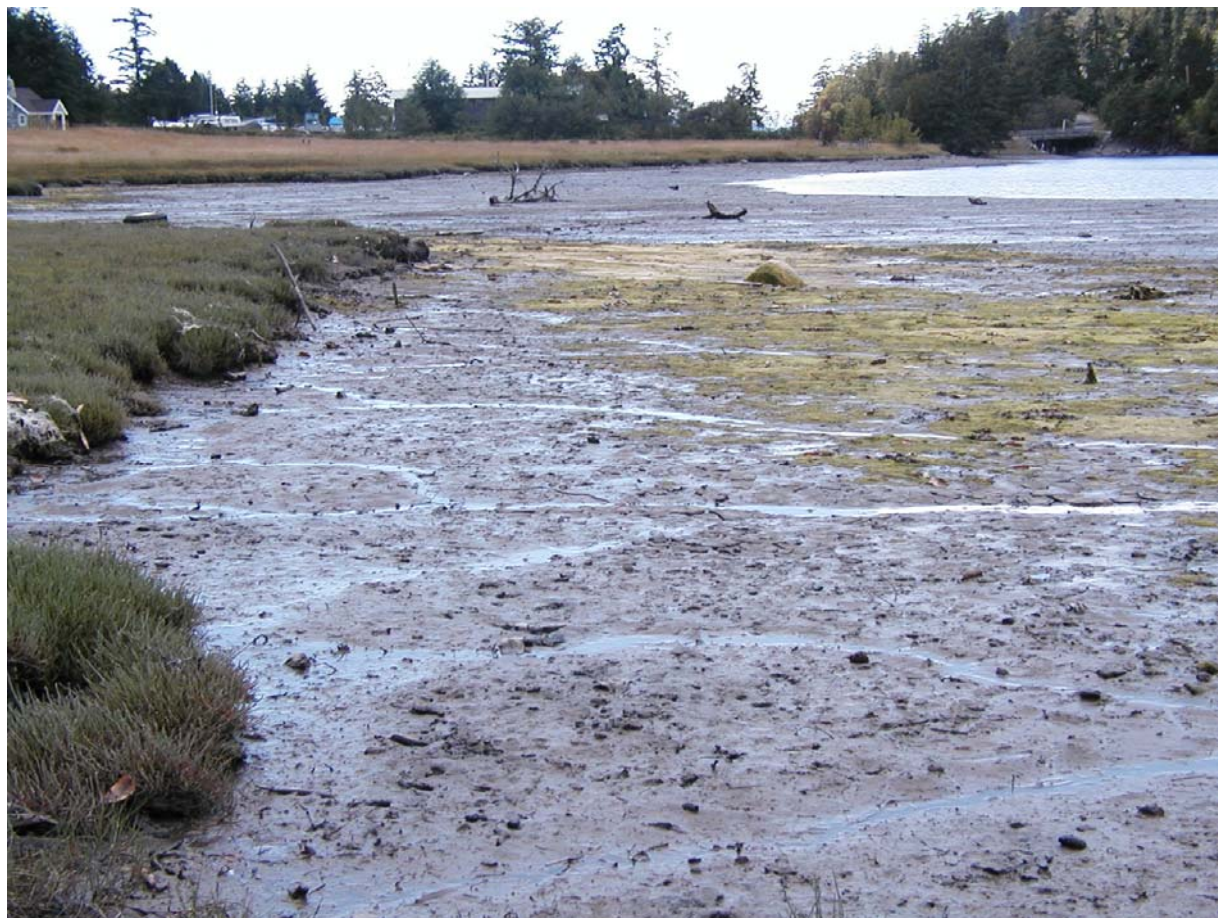
Figure 2.11 Seepage From the Eastern Shore of Cayou Valley Lagoon - July 2003

Freshwater seepage into Cayou Valley Lagoon is most obvious along the eastern shore, as seen here during July 2003. *Salicornia* low salt marsh is visible to the left. Monitoring of lagoon water quality in this area on weak ebb tides after rain events in December 2003 measured salinities in the range of 8 to 18 parts per thousand, compared with concentrations of about 30 ppt near the lagoon outlet. The green seaweed (*Ulva sp.*) may be associated with the brackish water.
